**SHIQAQ HAI MUSALLA
PRIMARY HEALTHCARE CENTER
KIRKUK, IRAQ**

SUSTAINMENT ASSESSMENT

**SIGIR PA-08-157
APRIL 13, 2009**

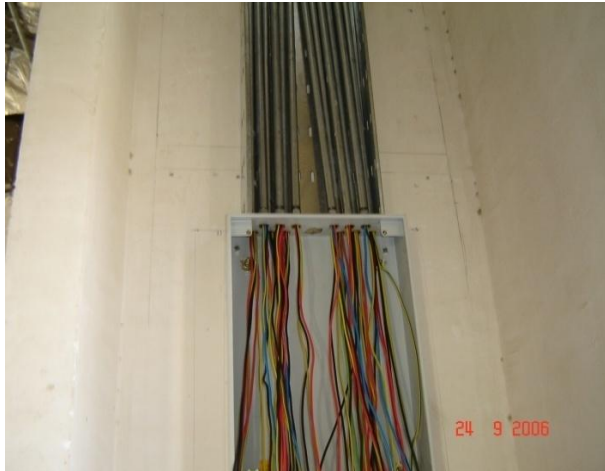
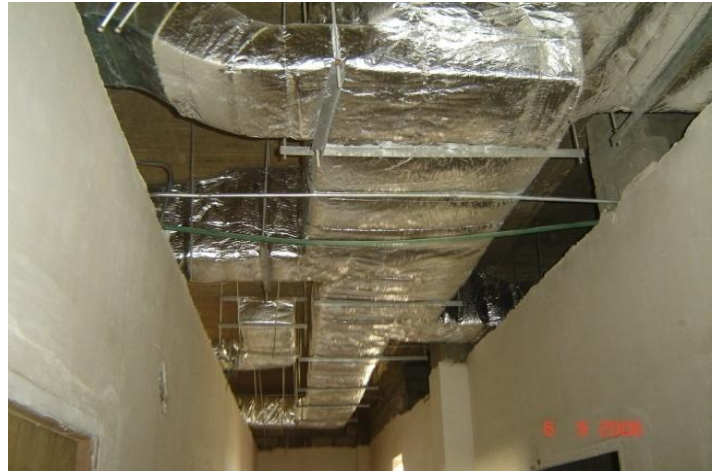
**Site Photos 2 and 3. Installation of electrical wiring and HVAC duct work, respectively
(Courtesy of USACE)**

Site Photos 2 and 3 document various construction work activities at the PHC, including electrical wiring and HVAC installation.

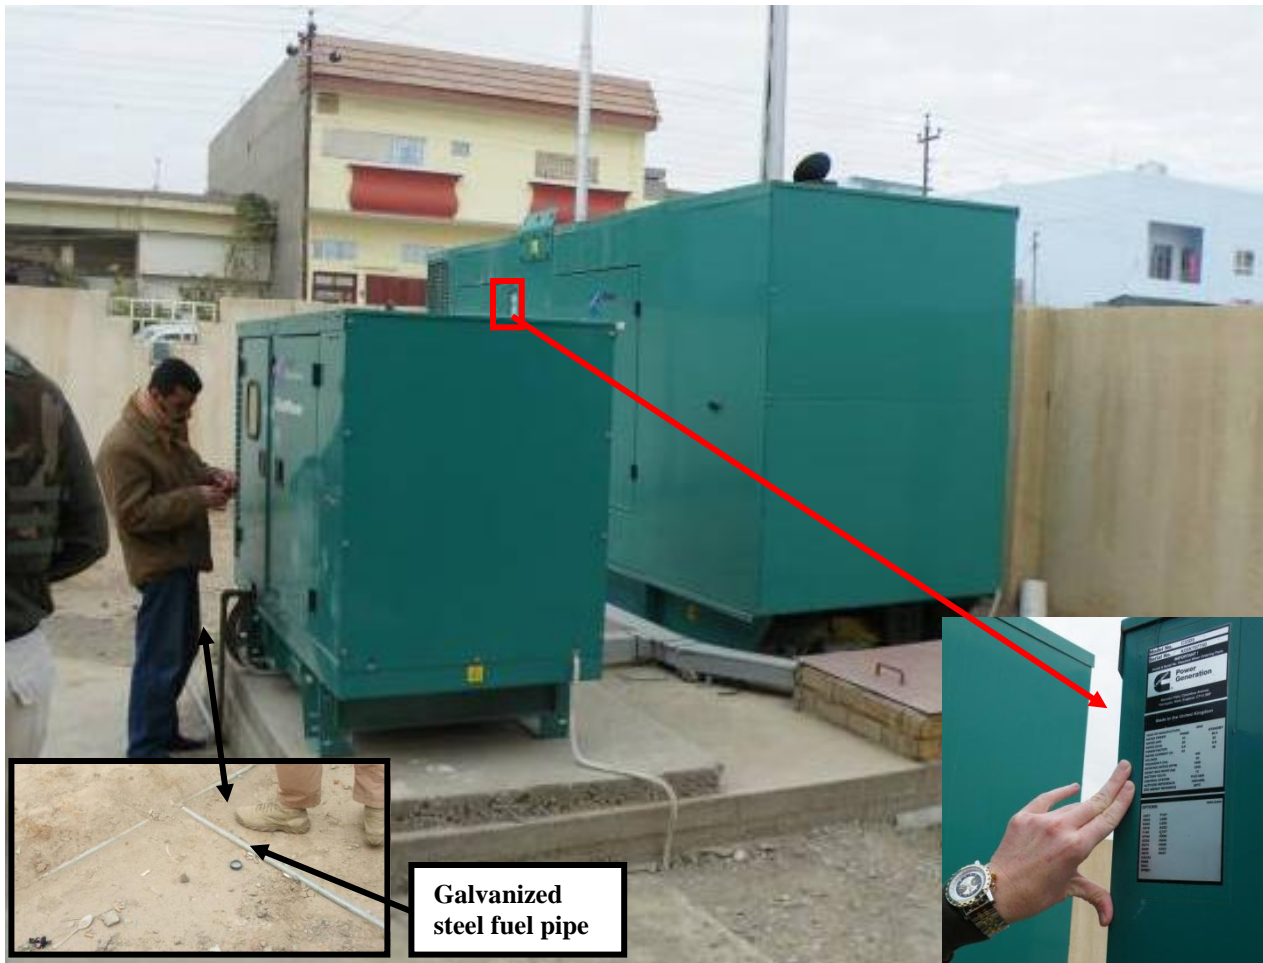
Site Photo 4. Two generators providing primary and emergency backup power for the PHC

The Shiqaq Hai Musalla PHC is connected to the national grid; however, the national grid is unreliable and provides approximately four hours of electricity per day. The primary source of electricity for the facility is provided from one of the two generators located on site (Site Photo 4). The larger generator, one-megawatt, is used for primary power; while the smaller generator, 500-kilovolt, is for emergency backup. During the site visit, the generators appeared to be relatively clean and in working order. SIGIR verified the generators' specifications via the faceplates.

SIGIR noticed no visible evidence of fuel leaks in the fuel line or inside the generator housing. The fuel line appeared to be galvanized steel pipe that was placed on the surface of the ground (Site Photo 4). Galvanized steel is susceptible to corrosion and may over a long period of time create issues with fuel leaks. Without careful monitoring, small leaks may go undetected, potentially wasting fuel, increasing the risk of fire, harming the environment, and endangering the welfare of the occupants.
